FLIGHT MEASUREMENTS OF THE EFFECT ON ELEVATOR STICK FORCES

OF STABILIZER INCIDENCE AND ELEVATOR RIB SPACING

ON THE P-63A-1-BE SERIES AIRPLANE

MEMORANDUM REPORT

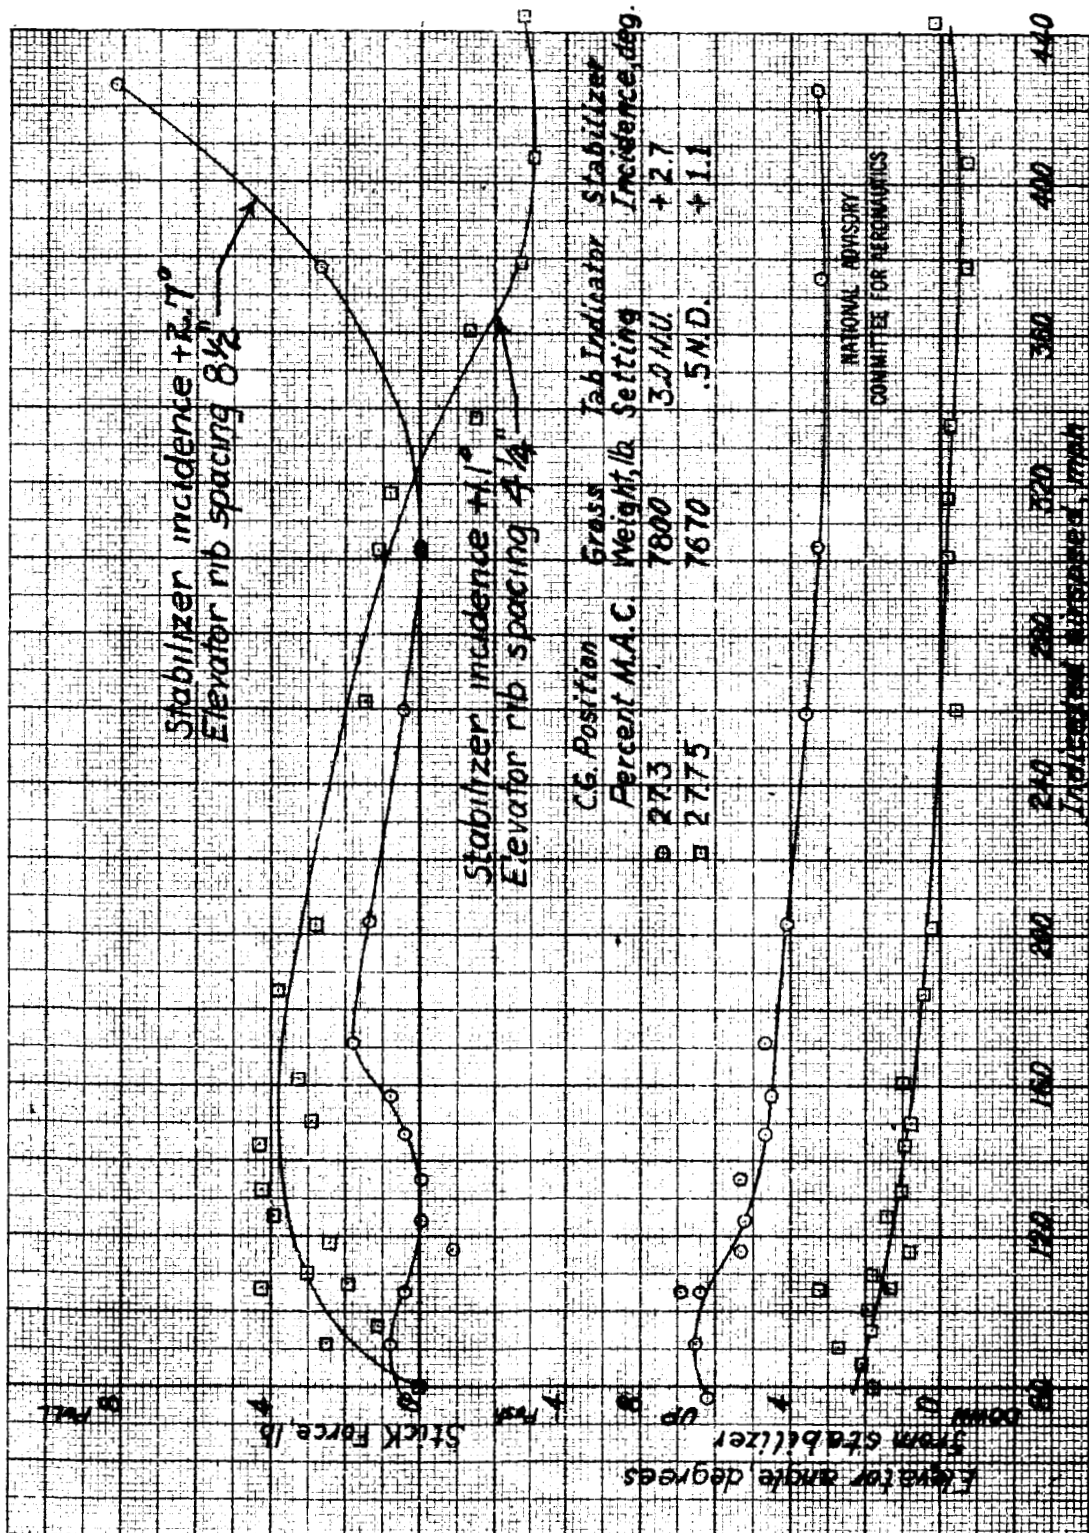
Figure 9 shows a comparison of the static longitudinal stability of the P-63A-1 airplane with normal rated power for comparable center-of-gravity locations with the two different stabilizer incidence and elevator rib spacing combinations tested. Figure 10 is a similar plot for the engine-idling condition. Figures 9 and 10 show that two important effects resulted from decreasing the stabilizer incidence and reducing the elevator rib spacing. First, with the stabilizer set  $2.7^\circ$  up from the thrust axis, the elevator angle for trim in high-speed straight flight was over  $3^\circ$  up from the stabilizer; whereas, with the stabilizer set  $1.1^\circ$  up from the thrust axis, the elevator angle for high-speed trim was about  $0.5^\circ$  down from the stabilizer. Second, increasing pull stick forces with increasing speed were necessary to maintain trim at high speed with the high incidence  $8\frac{1}{2}$ -inch rib-spaced elevator combination; whereas, with the low incidence  $4\frac{1}{4}$ -inch rib-spaced combination, push stick forces were required to maintain trim throughout the high-speed range tested. Tests made at the Bell Aircraft Corporation showed that increasing the number of elevator ribs decreased the magnitude of the pull stick forces which occurred with the stabilizer set  $2.7^\circ$  up from the thrust axis. The installation of a metal-covered elevator further reduced the magnitude of the pull stick forces which occurred with the original incidence of  $2.7^\circ$  up from the thrust axis but did not cause the force variation with speed to follow a stable trend. Therefore, test data indicate the departure from a stable variation of the stick force versus speed curve was associated with the excessively high stabilizer setting. It is believed that this high stabilizer setting affected the manner of distortion of the elevator covering and possibly resulted in twisting the stabilizer at high speeds.

Figure 9. - Data showing the effect of stabilizer incidence setting and elevator rib spacing on the static longitudinal stability characteristics of the P-63A-1 airplane. Clean condition, normal rated power (2600 RPM, 43 in. Hg), altitude range 5-10,000 feet.

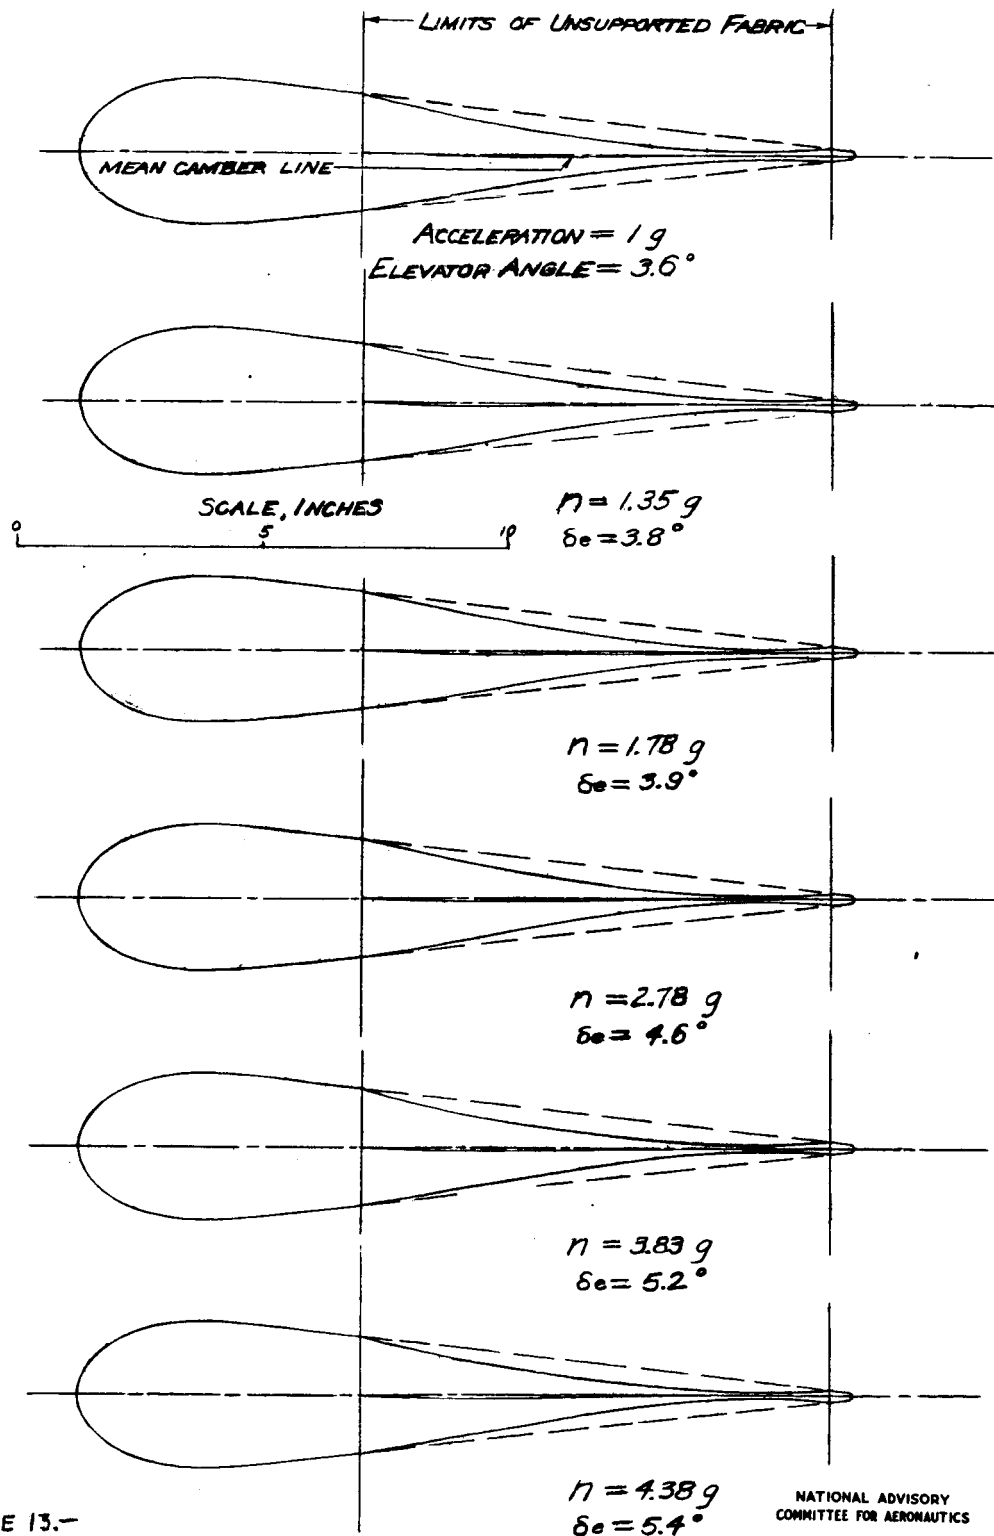
FIGURE 13.-

Figure 13 represents a series of elevator section shapes measured in turns at  $V_{is} = 360$  miles per hour with the  $8\frac{1}{2}$ -inch elevator rib-spaced,  $2.7^\circ$  up from the thrust axis, stabilizer incidence combination. Figure 14 is a similar plot for the  $4\frac{1}{4}$ -inch elevator rib-spaced,  $1.1^\circ$  up from the thrust axis stabilizer incidence combination at  $V_{is} = 300$  miles per hour. In both cases the center

of gravity was at 27.5 percent mean aerodynamic chord. These figures indicate the amount of fabric deflection and warping of the elevator mean camber line was independent of normal acceleration or elevator angle at constant indicated airspeed, for the range of elevator angles used in these turns. There was no measurable difference between the variations of stick force with acceleration for the two stabilizer incidence, elevator rib-spacing combinations tested. For this reason the data are not shown. Both combinations tested had normal variations of stick force against acceleration up to 5g acceleration at constant indicated airspeeds below 360 miles per hour.

ELEVATOR SECTIONS AT CENTER OF PANEL NUMBER 4 SHOWING THE VARIATION OF FABRIC DEFLECTION WITH ACCELERATION AT AN INDICATED AIRSPEED OF 360 M.P.H. ELEVATOR ANGLES ARE GIVEN WITH RESPECT TO THE STABILIZER ( $\pm$  UP) STABILIZER INCIDENCE  $2.7^\circ$ . ELEVATOR RIB SPACING  $8\frac{1}{2}$  INCHES.
